# BOLTED FIELD REPAIR OF COMPOSITE STRUCTURES

J. C. Watson, et al.  
McDonnell Douglas Corporation  
McDonnell Aircraft Company  
P.O. Box 516  
St. Louis, Missouri 63166

Final Report

Repairs were demonstrated on both laminate thicknesses. The 3/16 inch laminate was typical of an AV-8B wing skin. The 1/2 inch laminate was typical of an F-18 wing skin. Three sizes of damage holes were investigated for each laminate thickness: 1.0 in., 2.5 in., and 4.0 in. diameters. Two repair concepts were evaluated for each damage configuration.

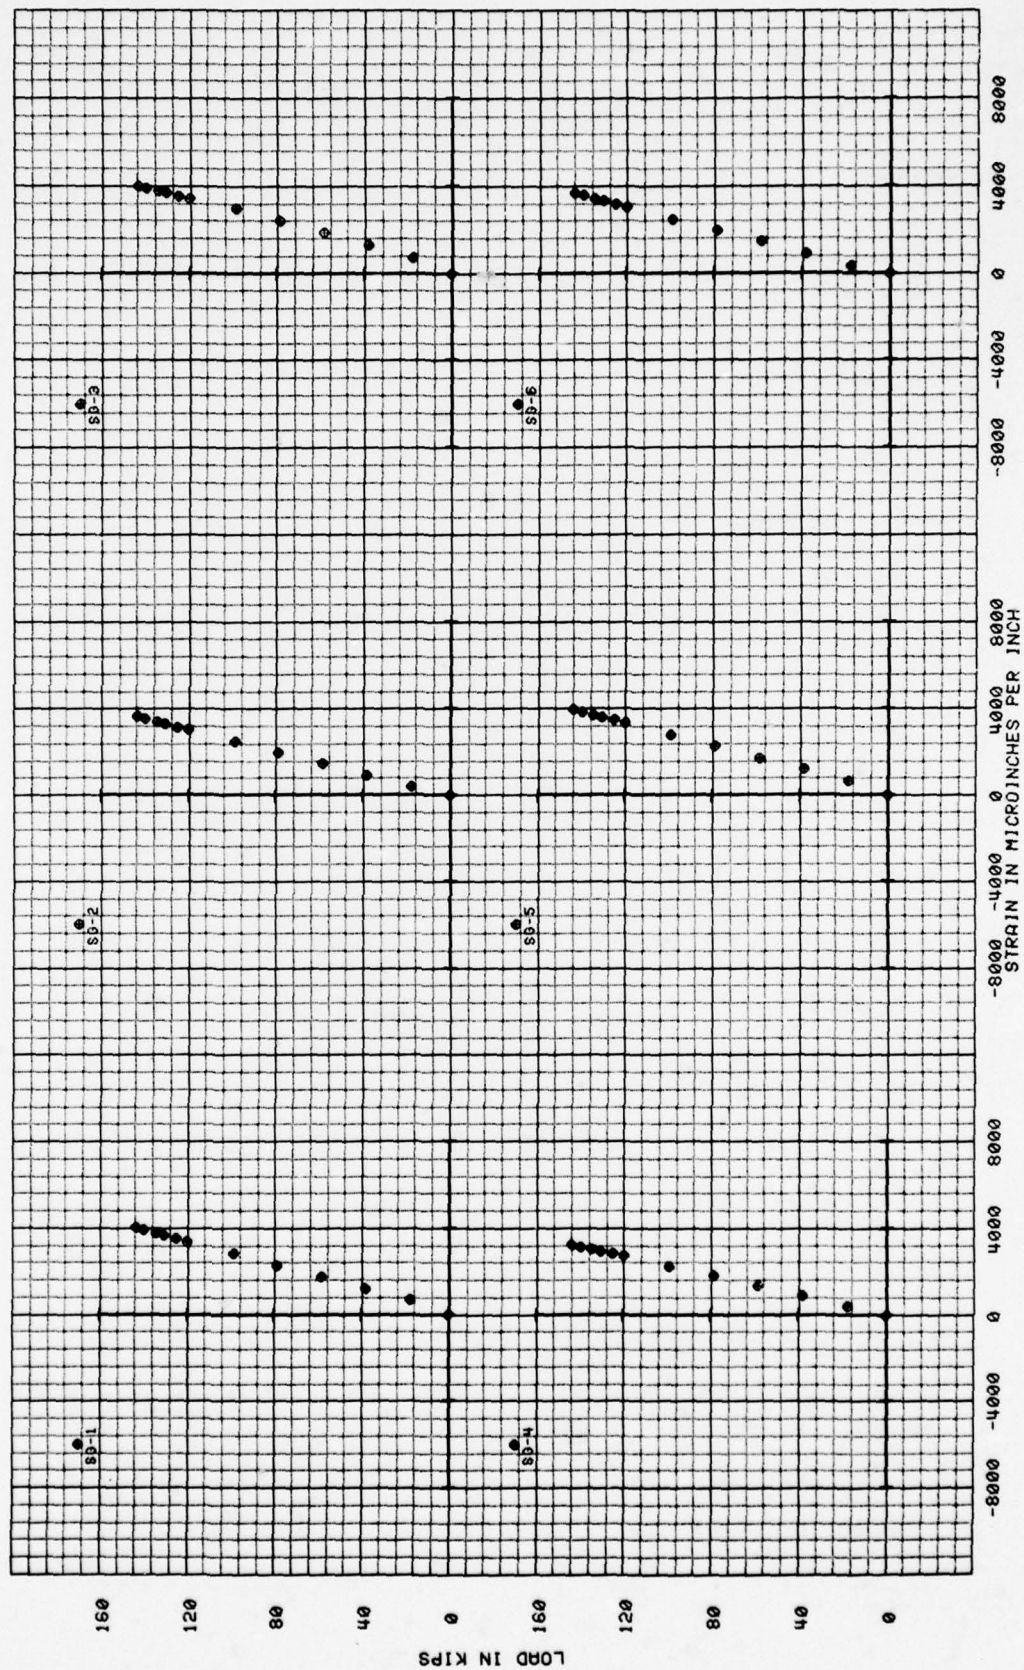
FIGURE B-23 Strain Gage Data 75T060106-1009  
1/2 Laminate 4.0 Dia Damage Hole

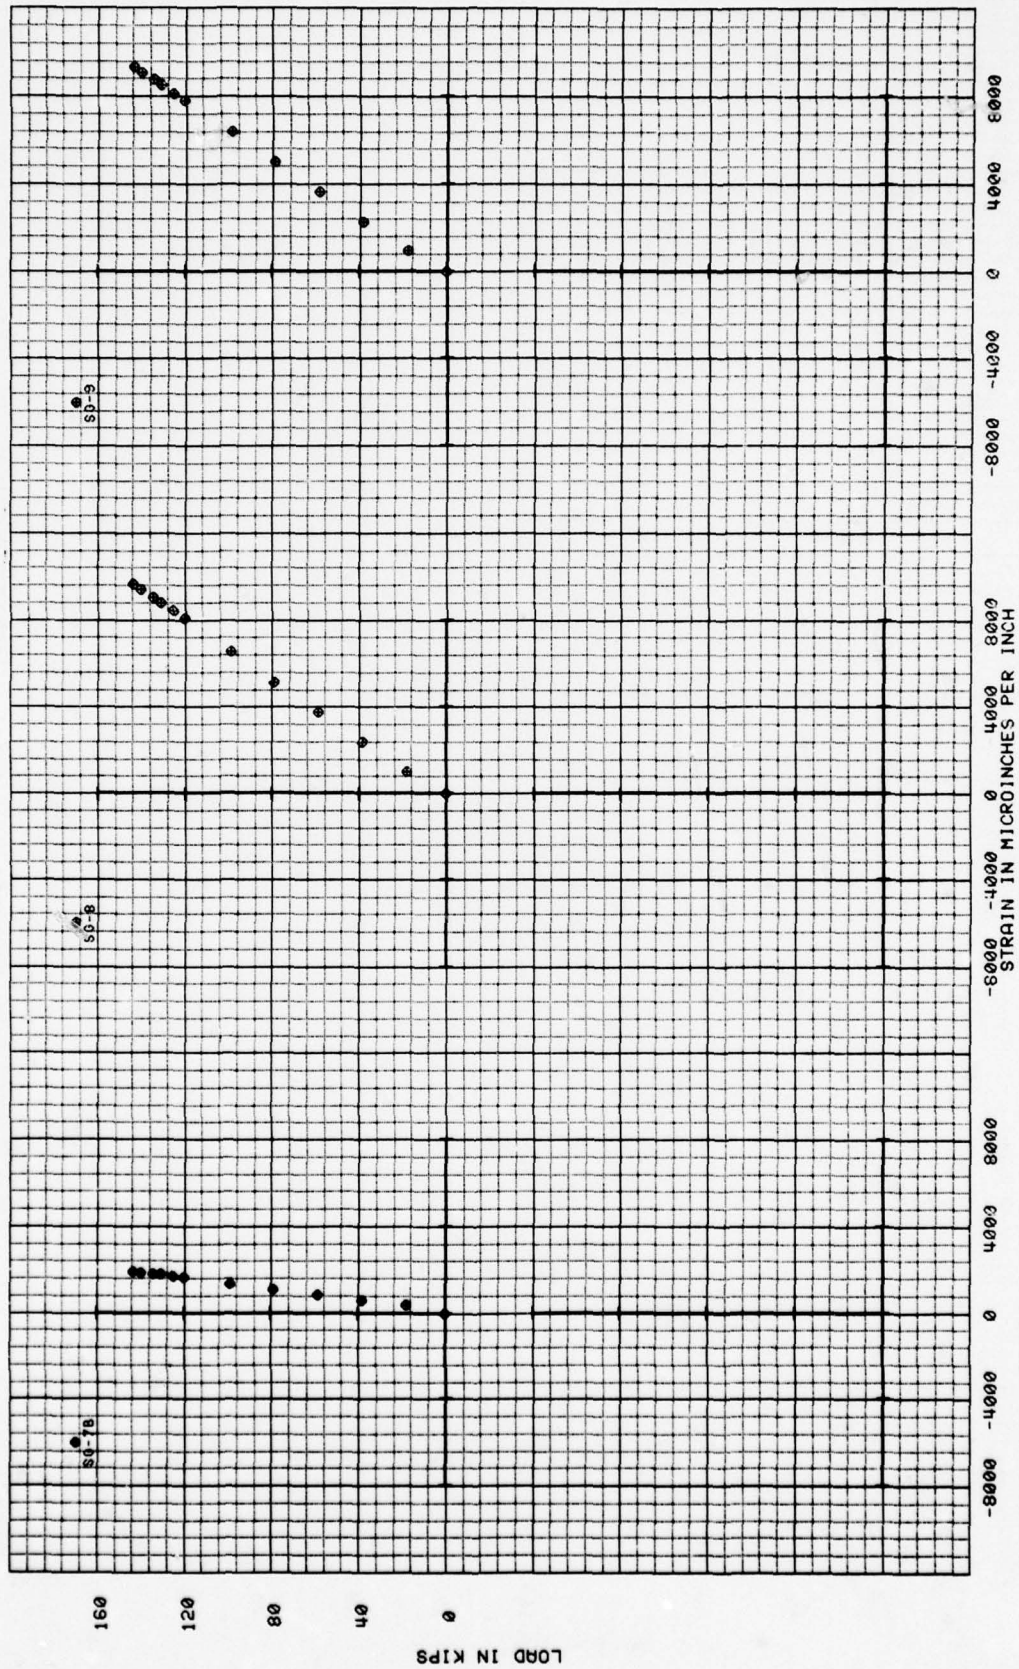
FIGURE B-23 Continued Strain Gage Data 75T060106-1009  
1/2 Laminate 4.0 Dia Damage Hole

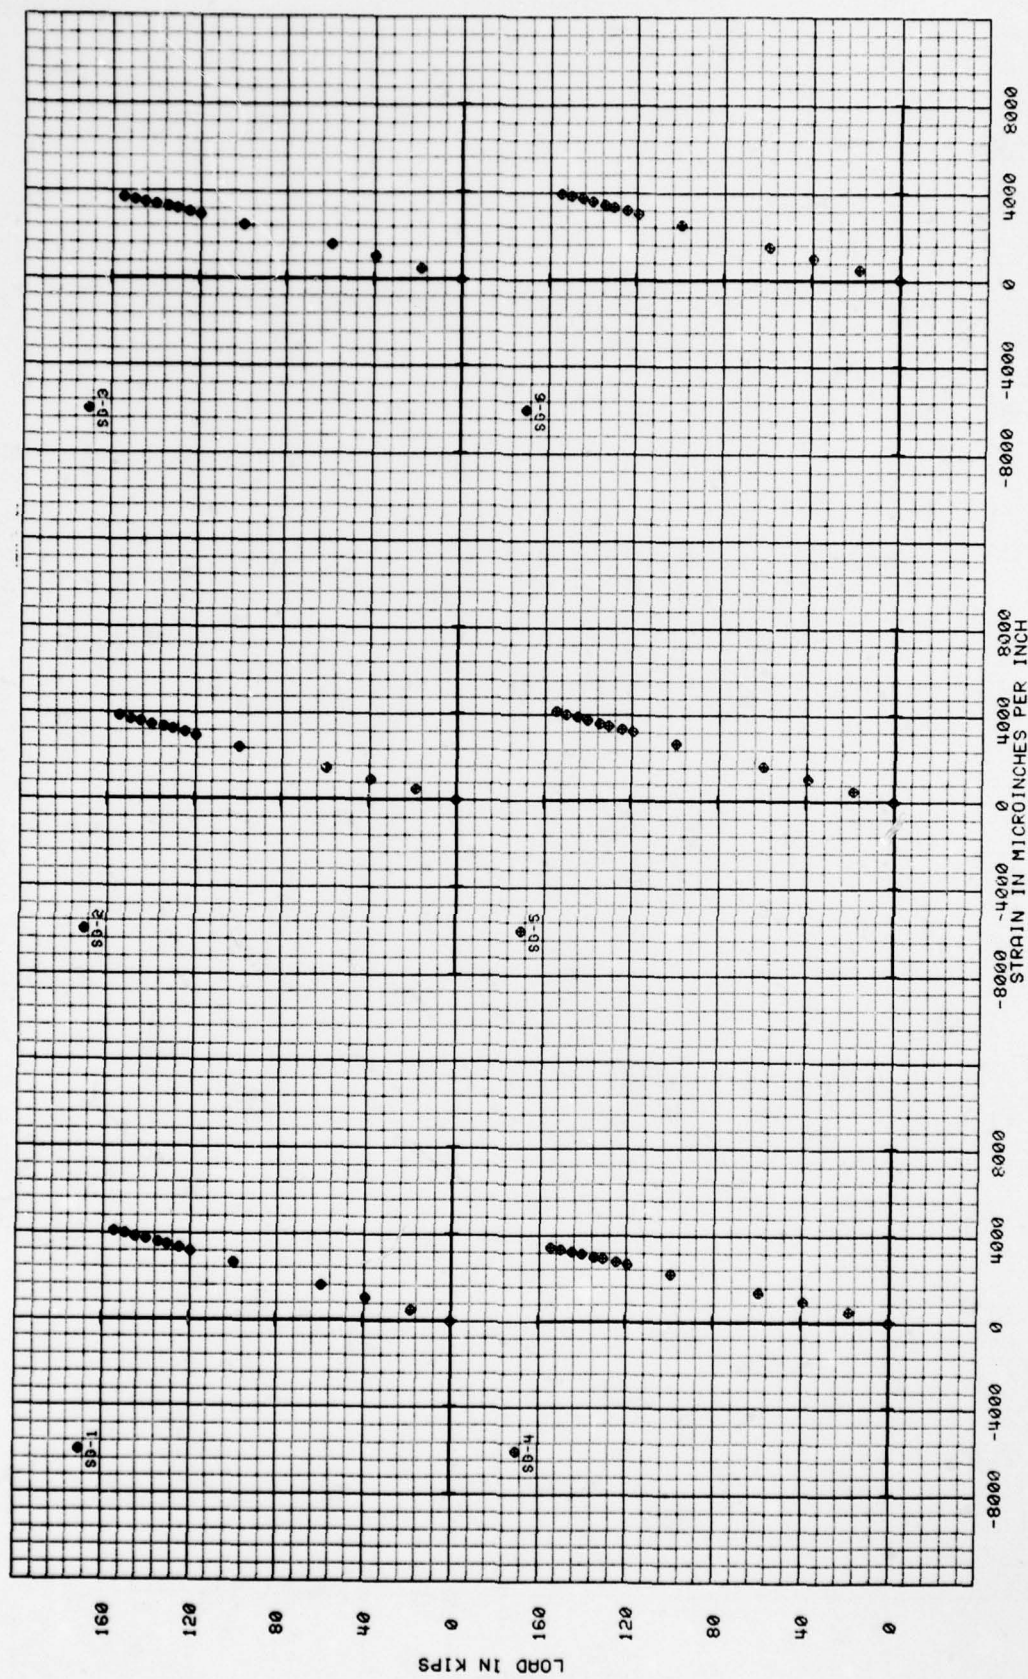
FIGURE B-24 Strain Gage Data 75T060106-1011 No. 1  
1/2 Laminate 4.0 Dia Damage Hole

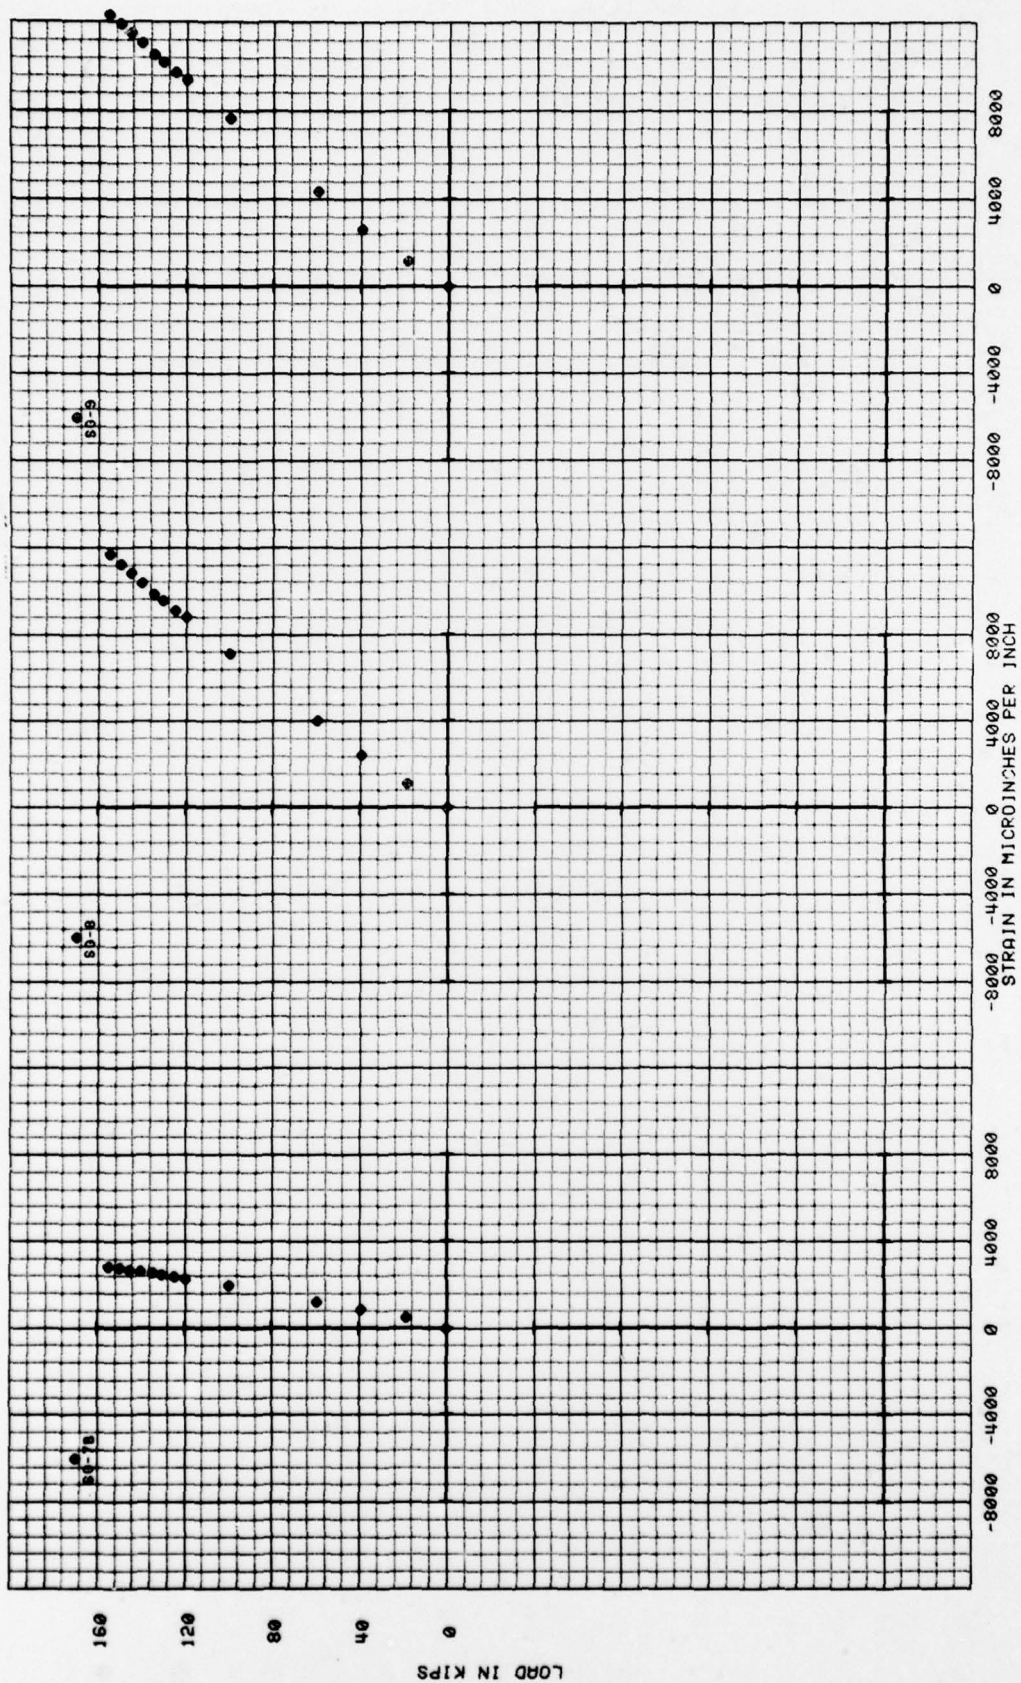
FIGURE B-24 Continued Strain Gage Data 75T060106-1011 No. 1  
1/2 Laminate 4.0 Dia Damage Hole

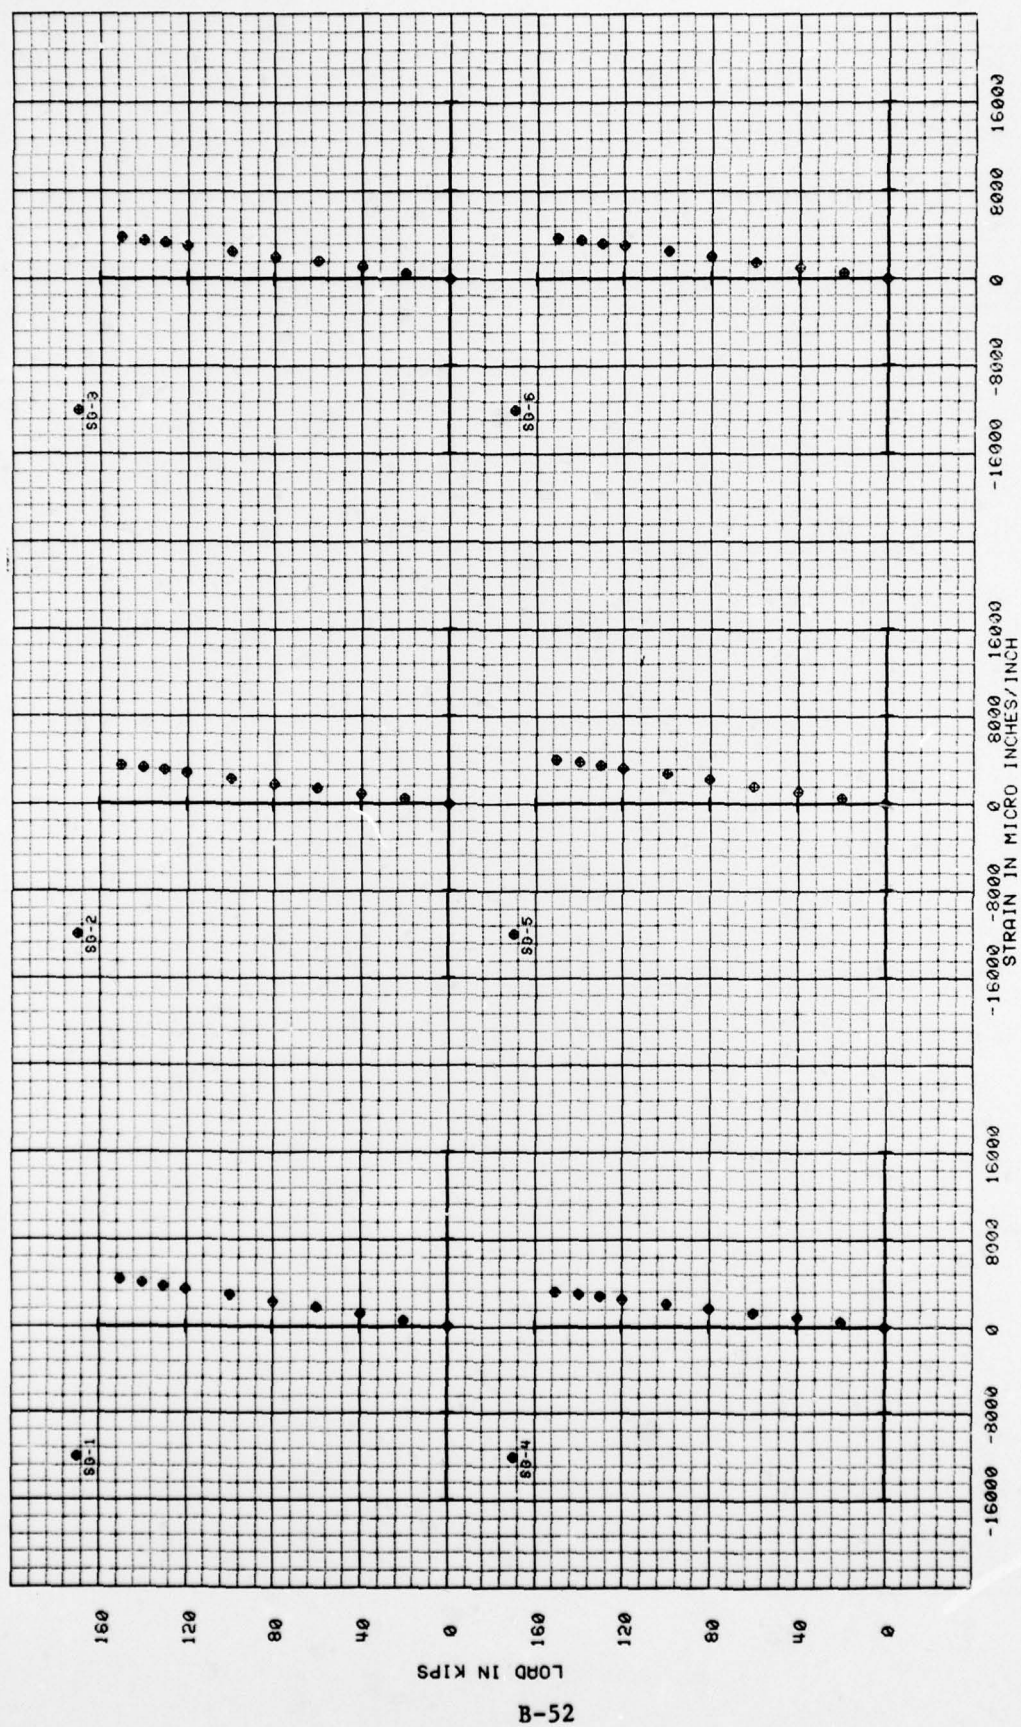
FIGURE B-25 Strain Gage Data 75T060106-1011 No. 2  
1/2 Laminate 4.0 Dia Damage Hole

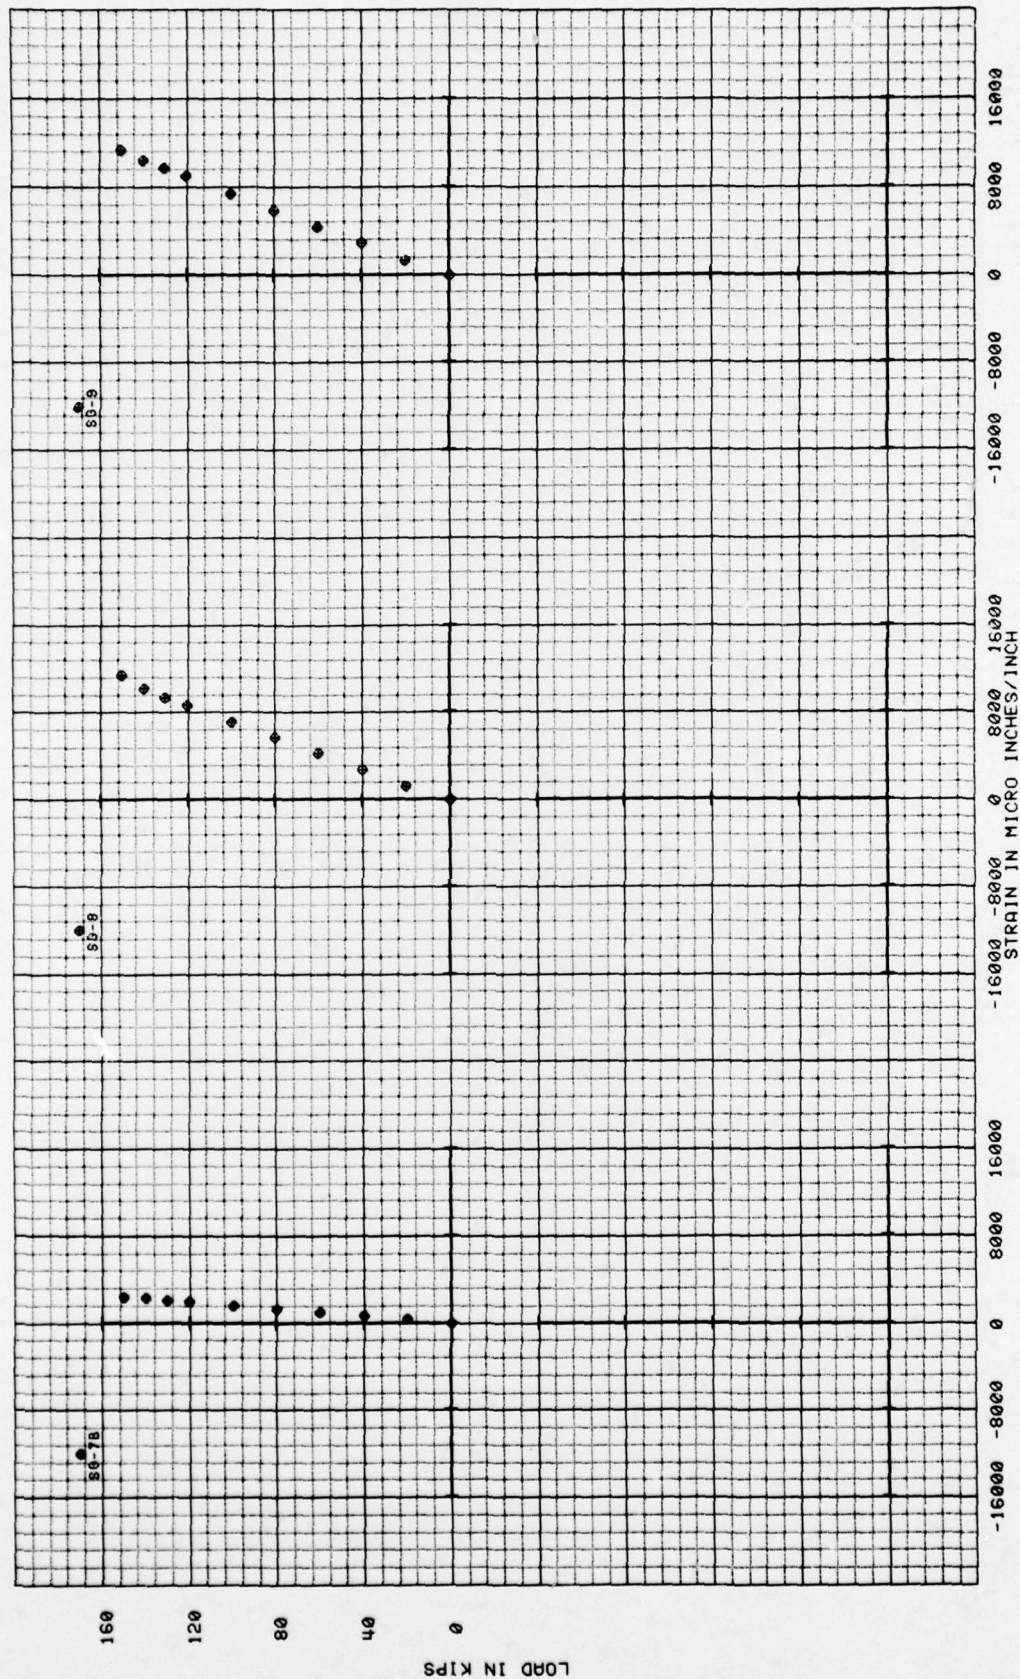
FIGURE B-25 Continued Strain Gage Data 75T060106-1011 No. 2  
1/2 Laminate 4.0 Dia Damage Hole

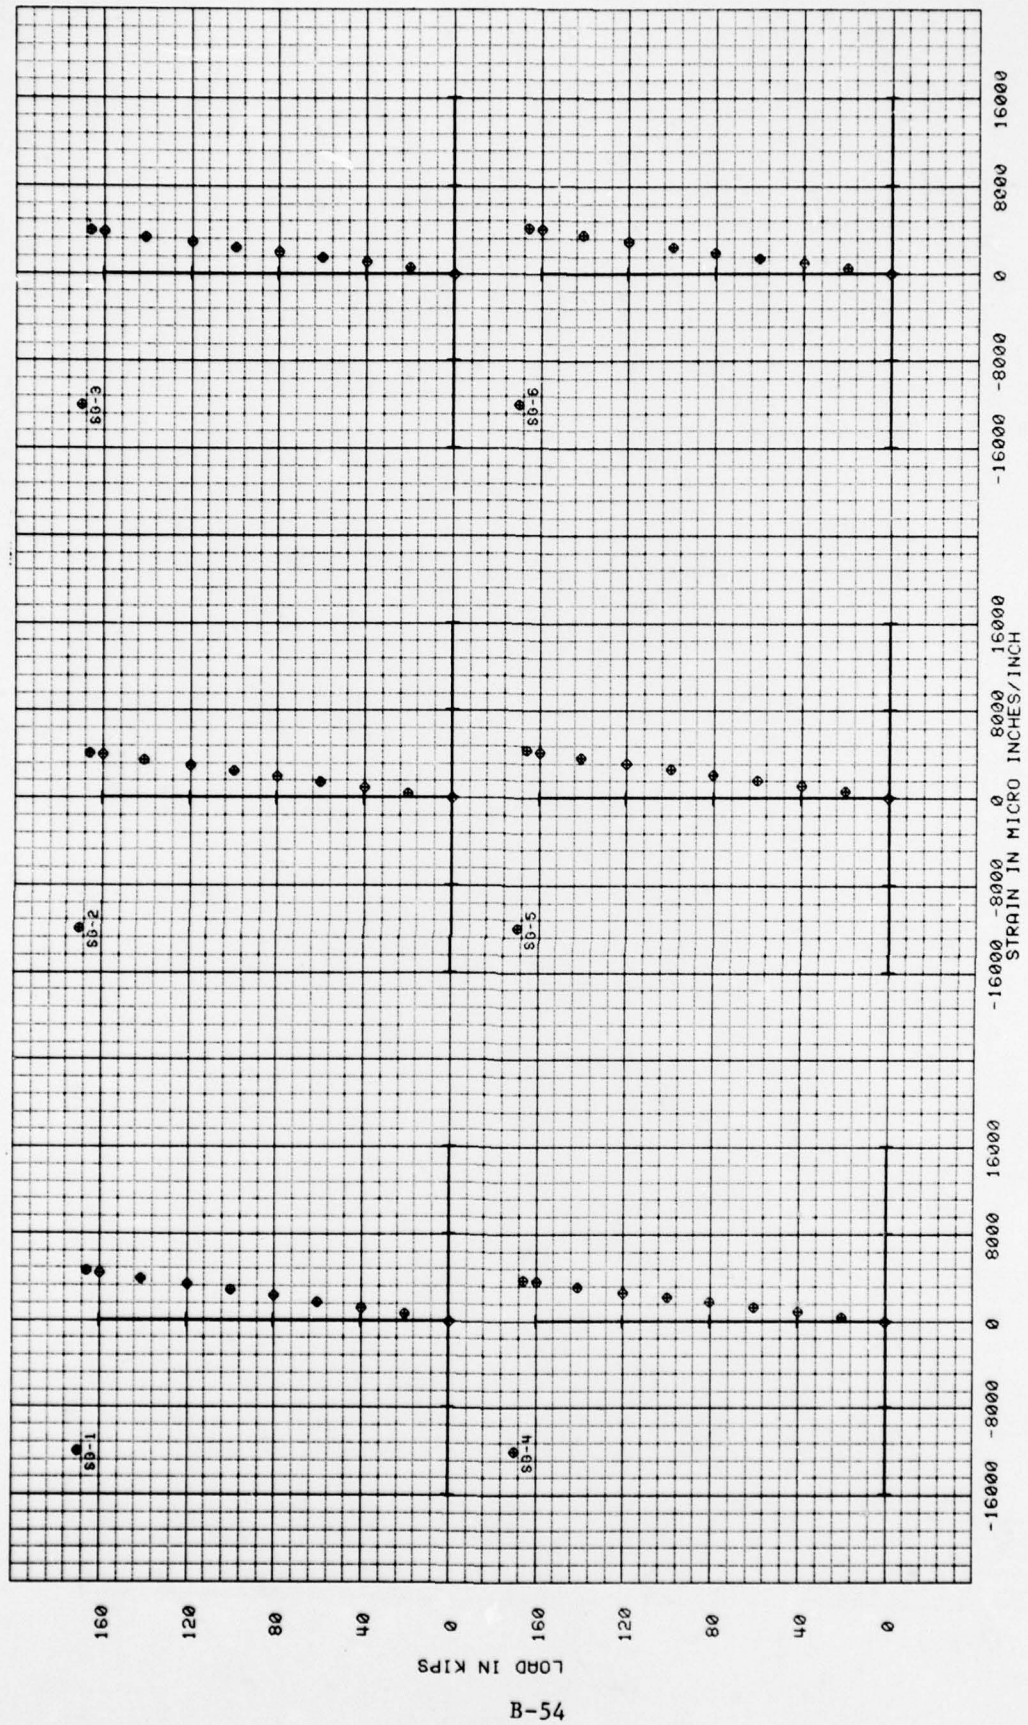
FIGURE B-26 Strain Gage Data 75T060106-1011 No. 3  
1/2 Laminate 4.0 Dia Damage Hole

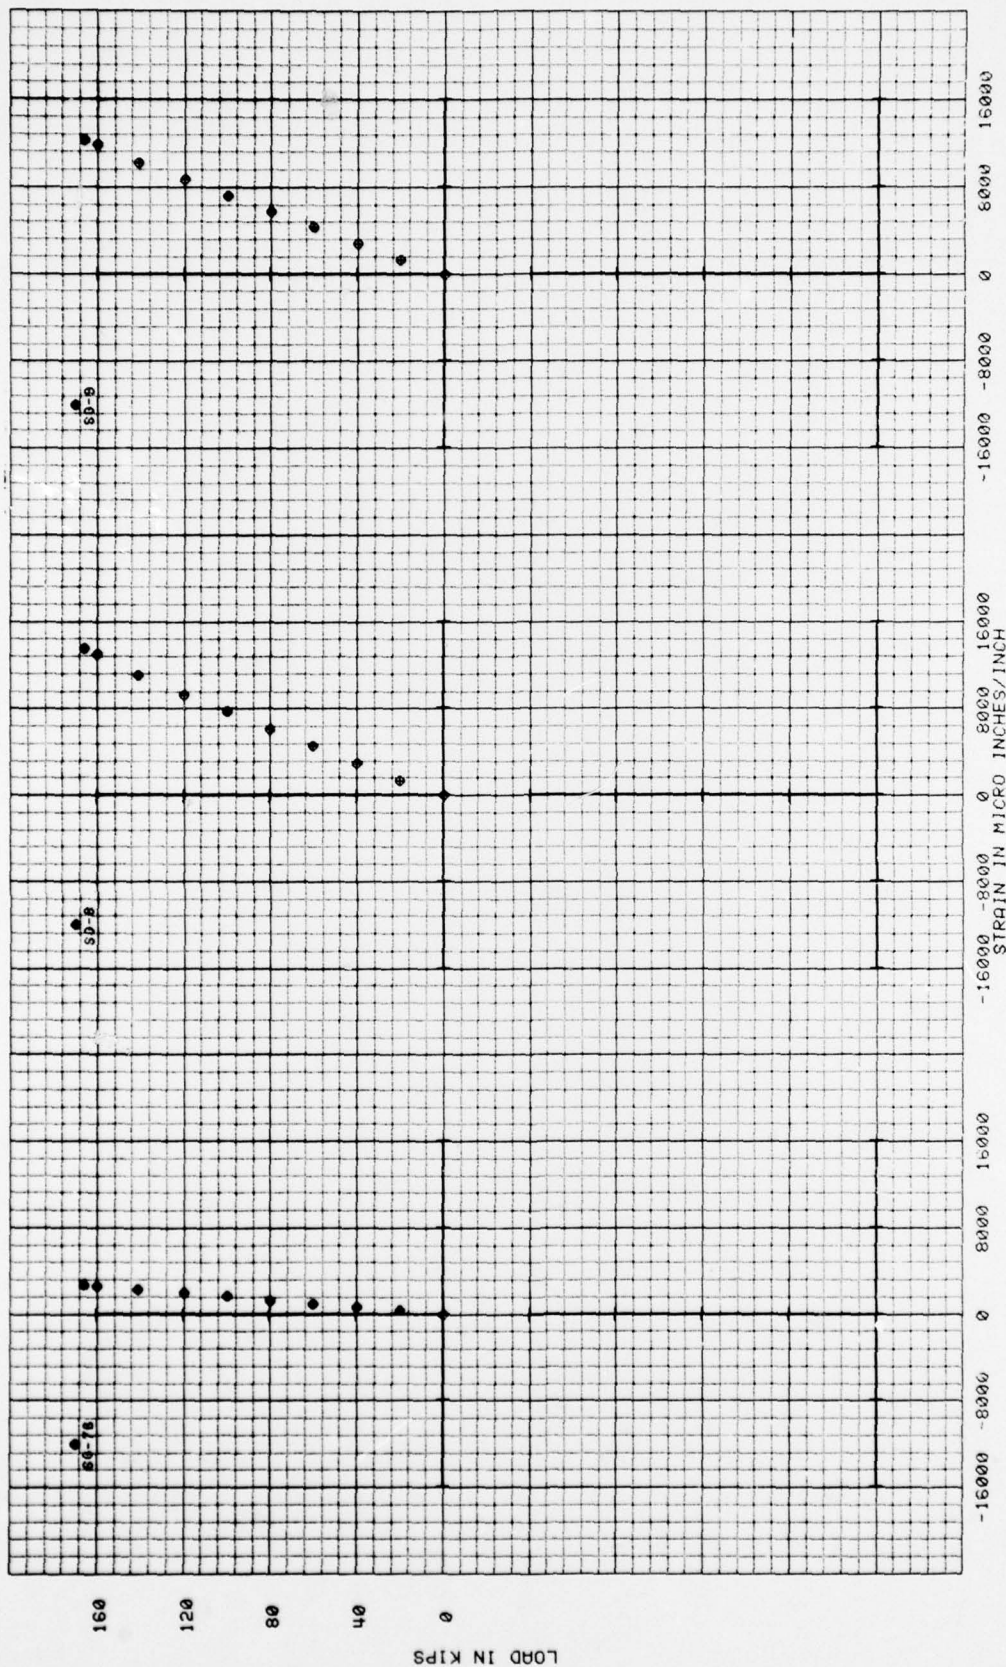
FIGURE B-26 Continued Strain Gage Data 75T060106-1011 No. 3  
1/2 Laminate 4.0 Dia Damage Hole

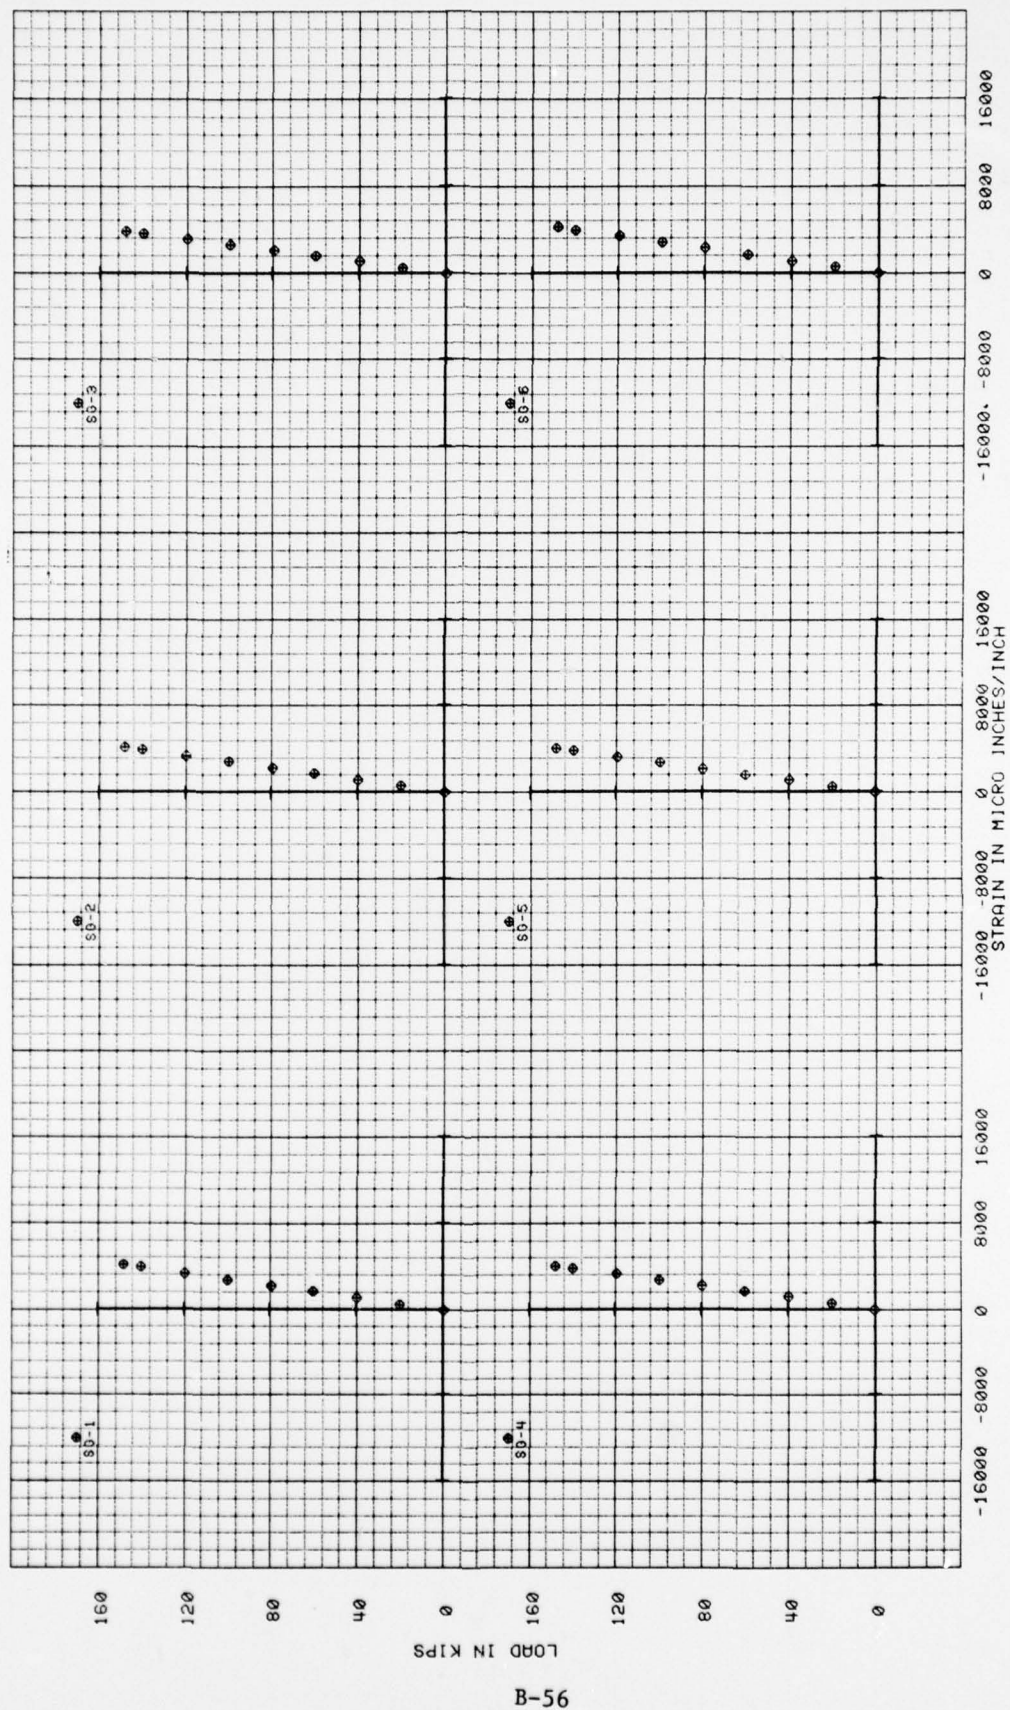
FIGURE B-27 Strain Gage Data 75T060106-1013  
1/2 Laminate Off Axis

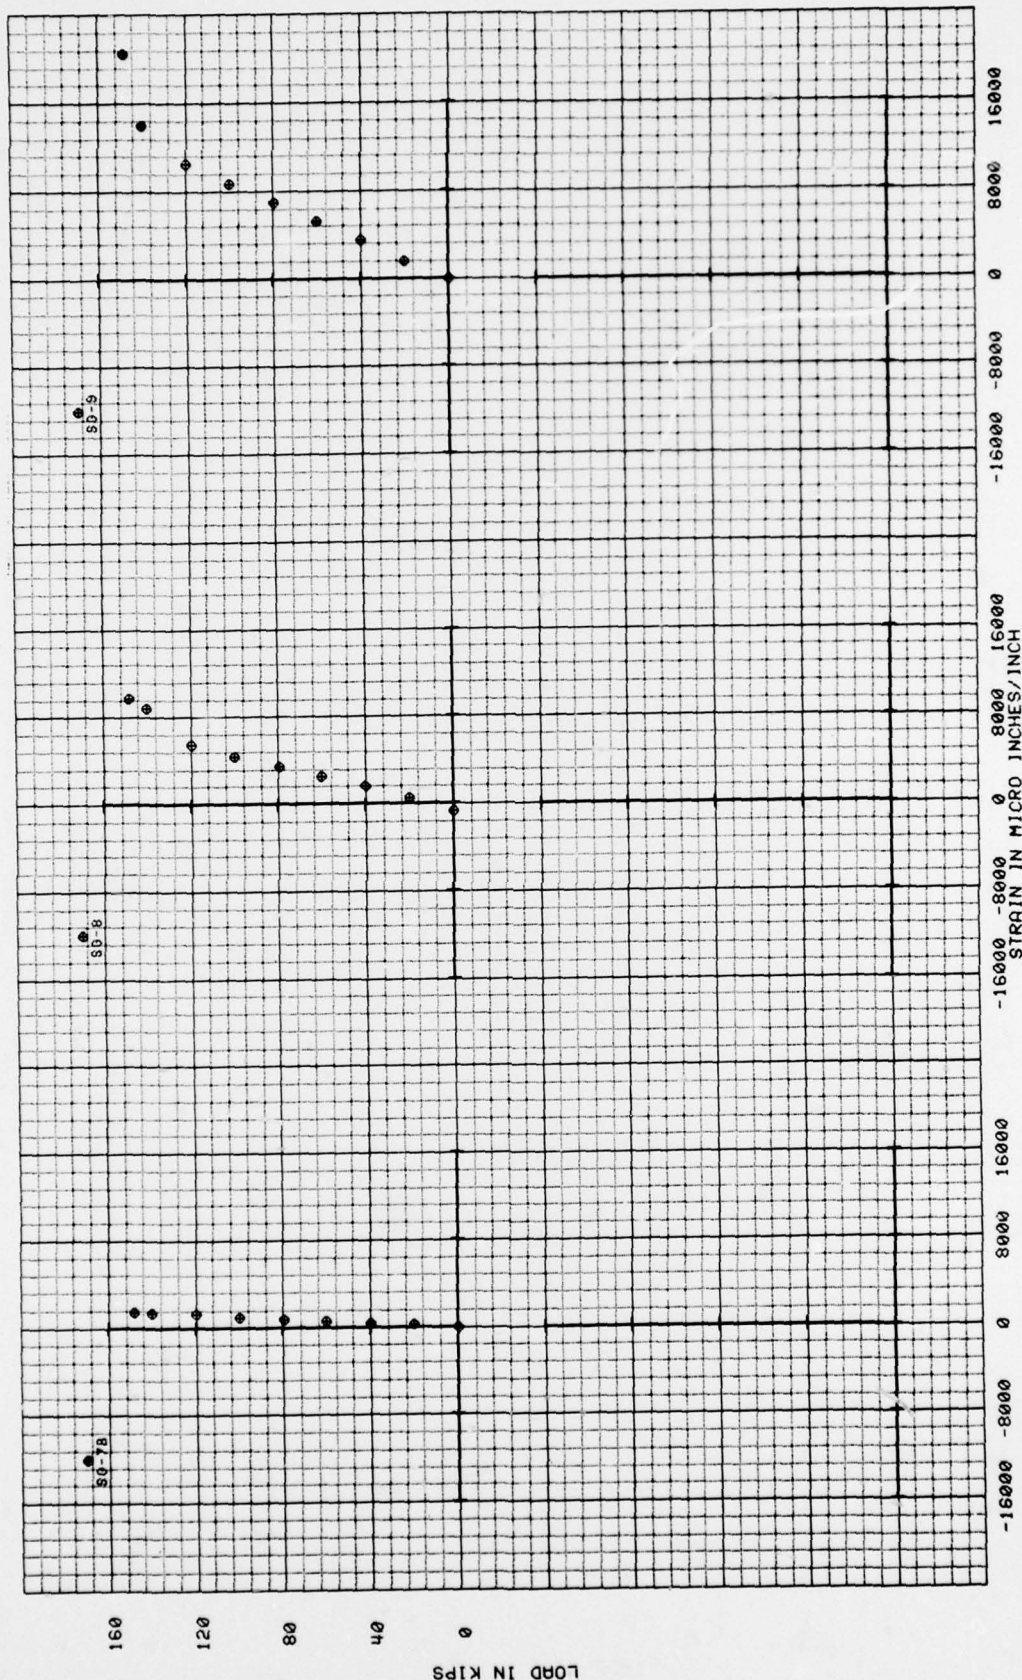
FIGURE B-27 Continued Strain Gage Data 75T060106-1013  
1/2 Laminate Off Axis

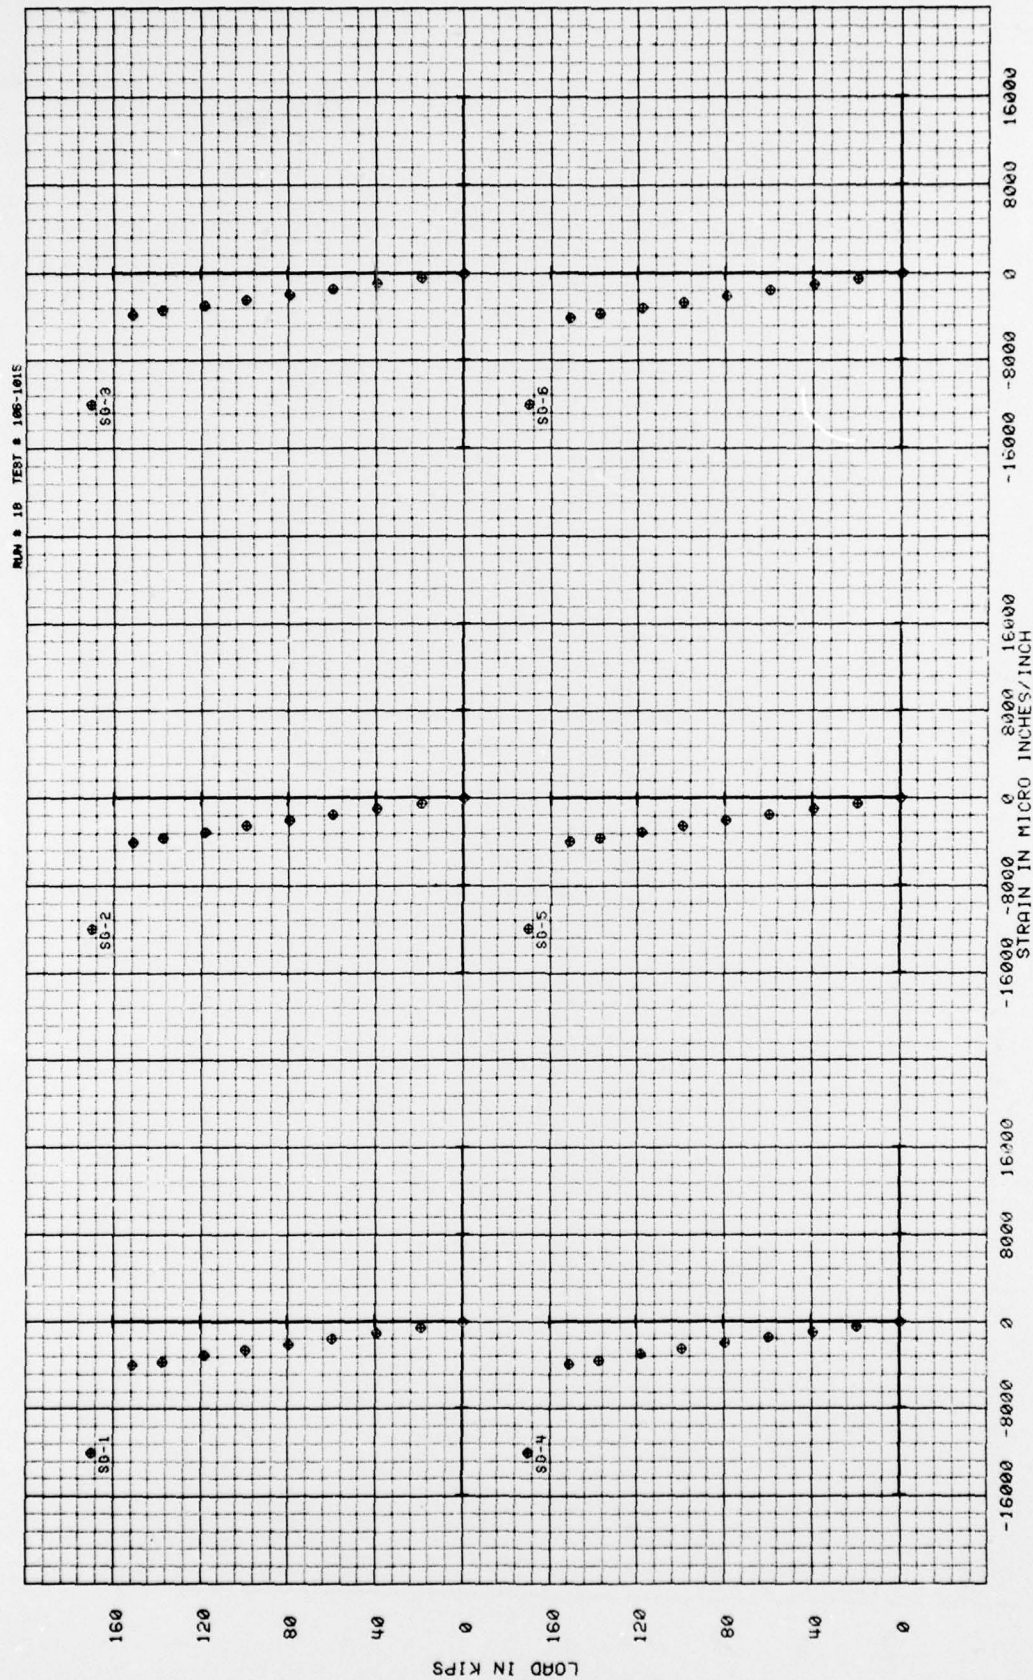
FIGURE B-28 Strain Gage Data 75T060106-1015  
1/2 Laminate Compression

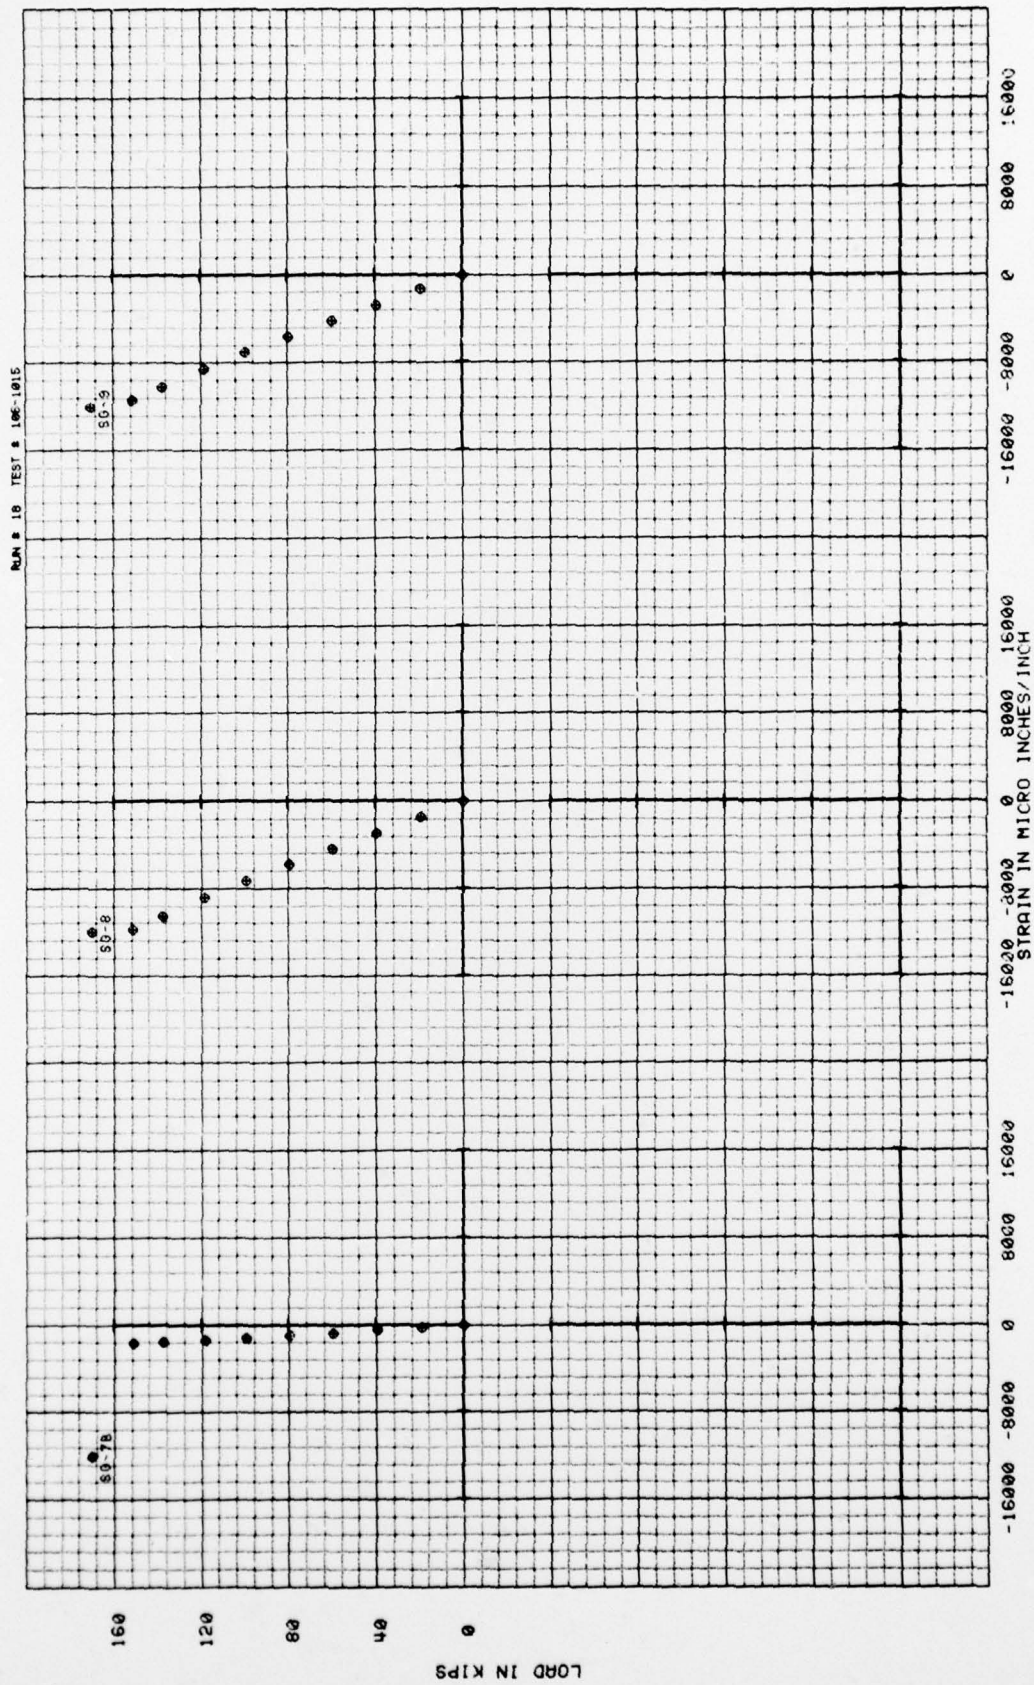
FIGURE B-28 Continued Strain Gage Data 75T060106-1015  
1/2 Laminate Compression

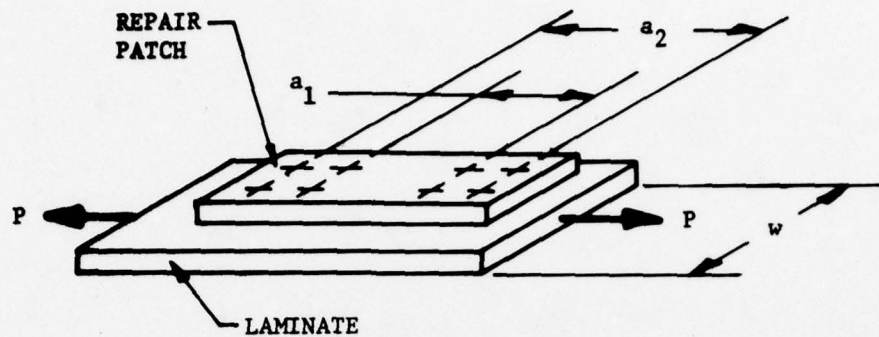
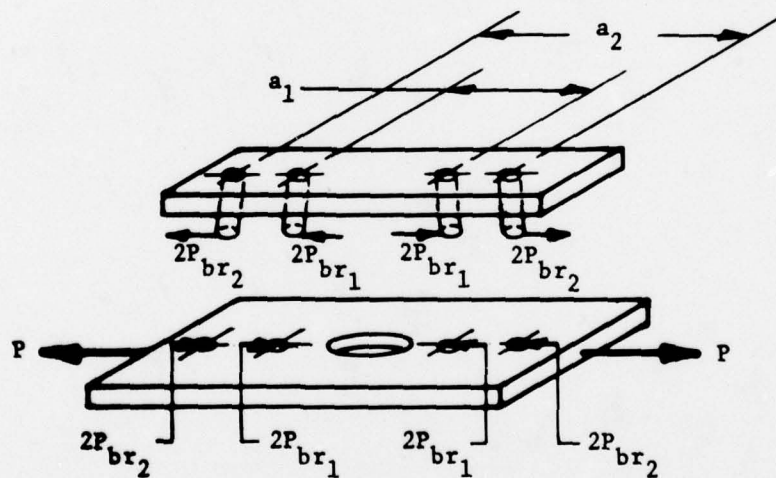
REPAIRED SPECIMEN

$P_{br1}$  &  $P_{br2}$  = BOLT SHEAR LOADS

COMPLIANCE MODEL IDEALIZATION

FIGURE C-1 COMPLIANCE METHOD REDUCES ANALYSIS OF REPAIR TO ONE DIMENSION

In this approach, the skin and the repair patch are idealized as bar members interconnected by flexible fasteners. The in-plane shear lag in both the skin and patch is neglected, and it is assumed that the bolt loads produce a state of uniform deformation across the width of the members.

Figure C-1 schematically illustrates the approach for a repair concept with two rows of fasteners on each side of the hole in the skin. The rows are separated by an axial distance of  $a_1$  and  $a_2$ . Each of the fasteners in Row 1 is loaded in shear by a bearing load  $P_{br1}$ ; likewise, each of the fasteners in Row 2 is acted upon by a bearing load  $P_{br2}$ .
